## **AXIS Q21 Thermal Camera Series**

**AXIS Q2101-TE Thermal Camera**

**AXIS Q2111-E Thermal Camera**

**AXIS Q2112-E Thermal Camera**

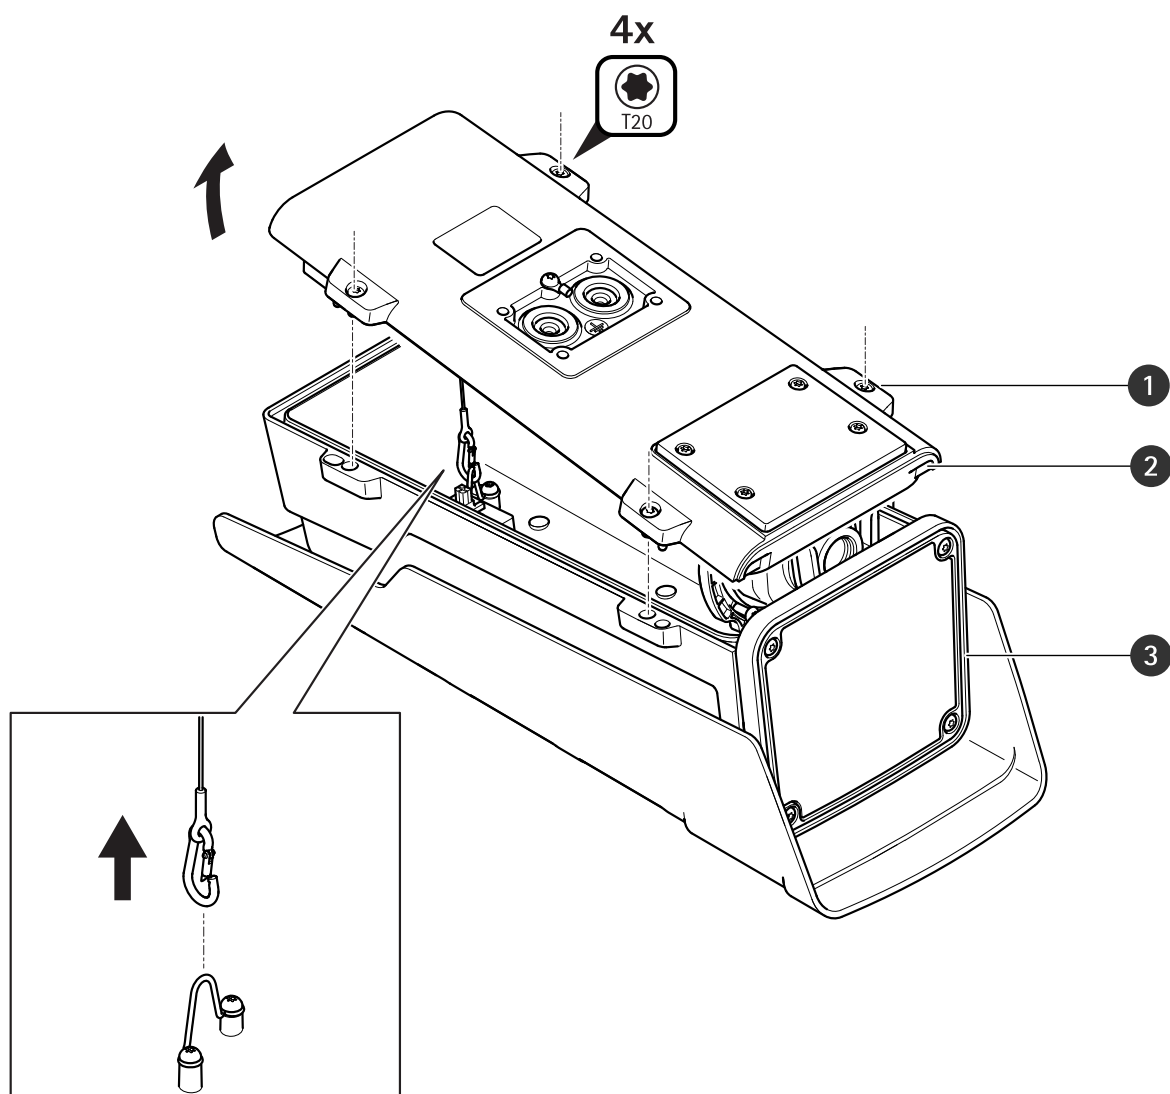
- 1 Screws (4x, T20)
- 2 Bottom chassis
- 3 Top cover

1. Remove the bottom chassis from the top cover.

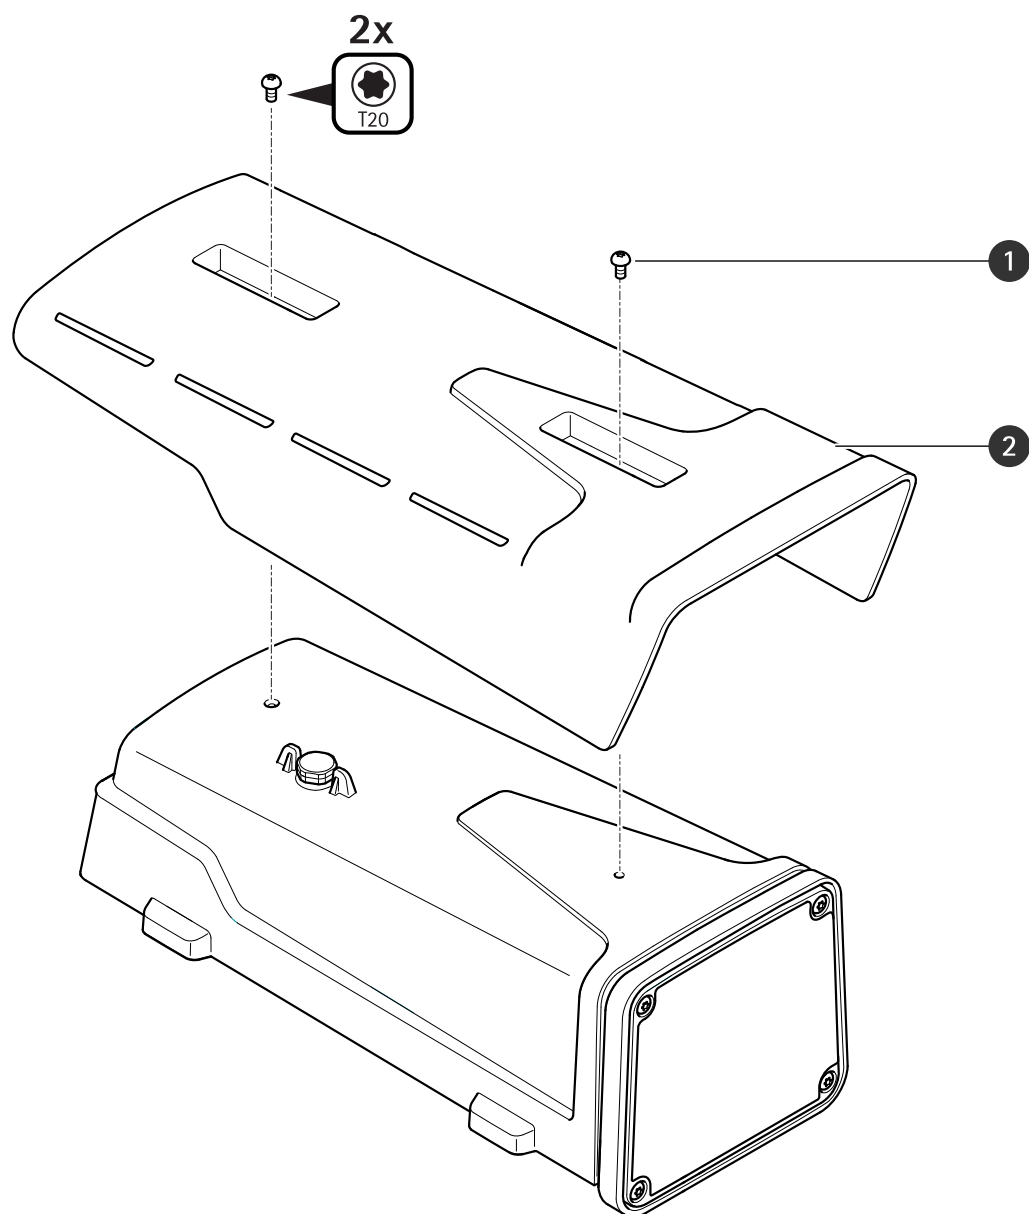
- 1 Screws (2x, T20)
- 2 Weathershield

2. Remove the weathershield from the top cover.

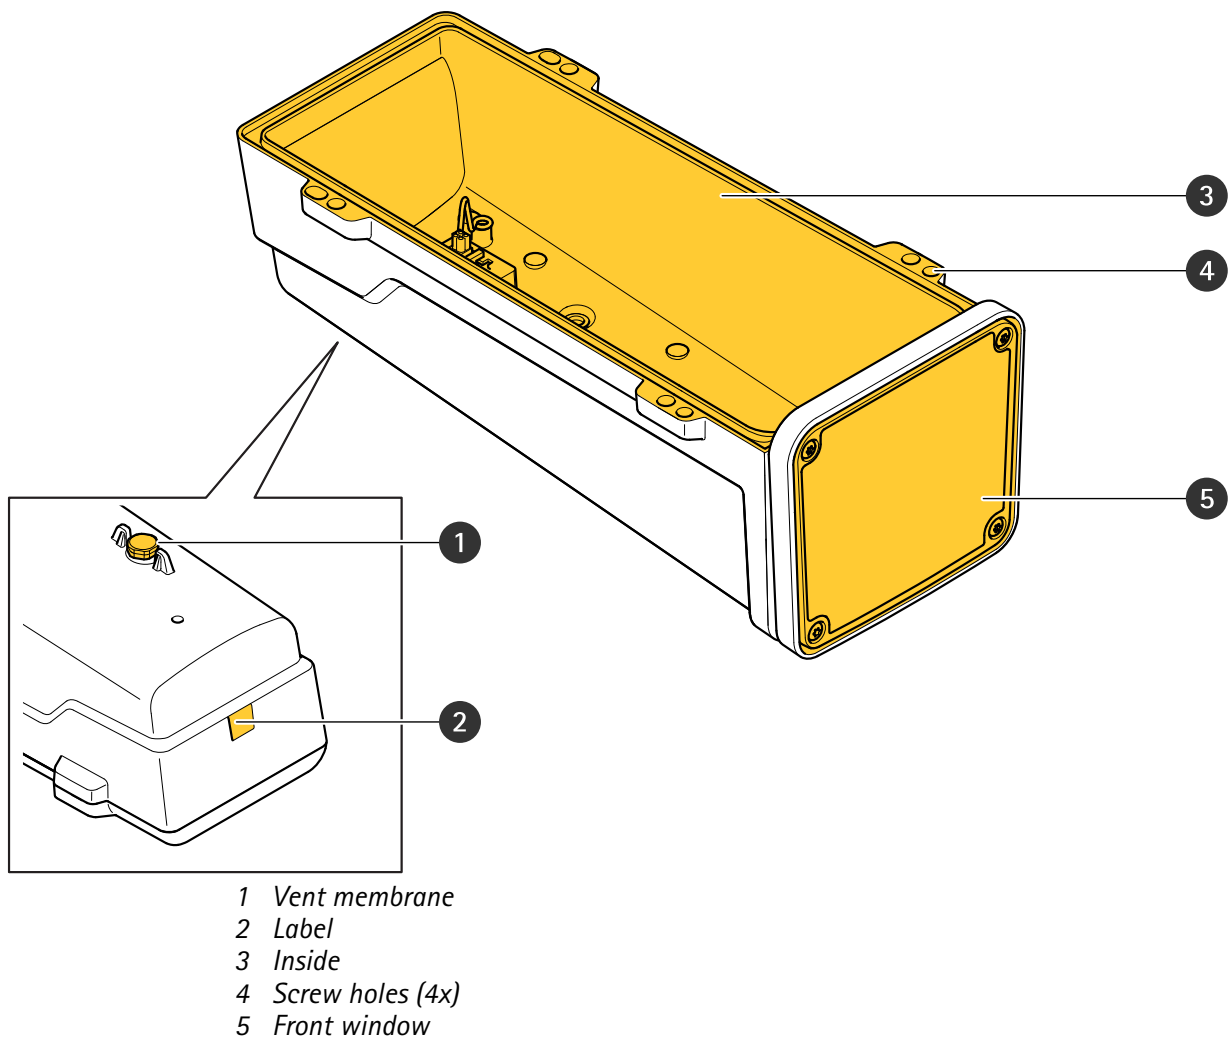
### Masking the top cover

Mask the following parts of the top cover:

1. The vent membrane.
2. The label.
3. Everything on the inside including the sealing surface to the bottom chassis.
4. The screw holes.
5. The front window including the black areas.

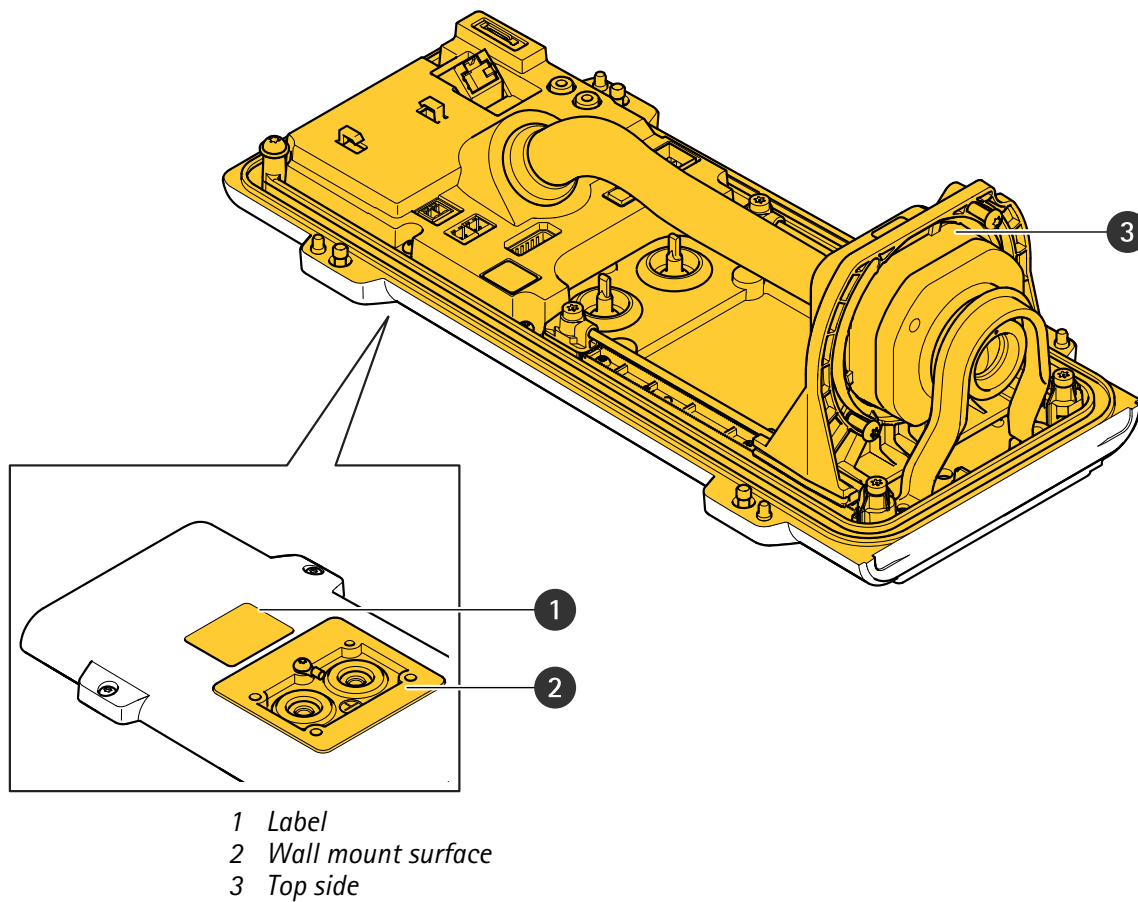
## Masking the bottom chassis

Mask the following parts of the bottom chassis:

1. The product label.
2. The surface under the adapter for the wall mount.
3. Everything on the top side of the bottom chassis, including the gasket and the four screw holes.
4. The four screw holes.

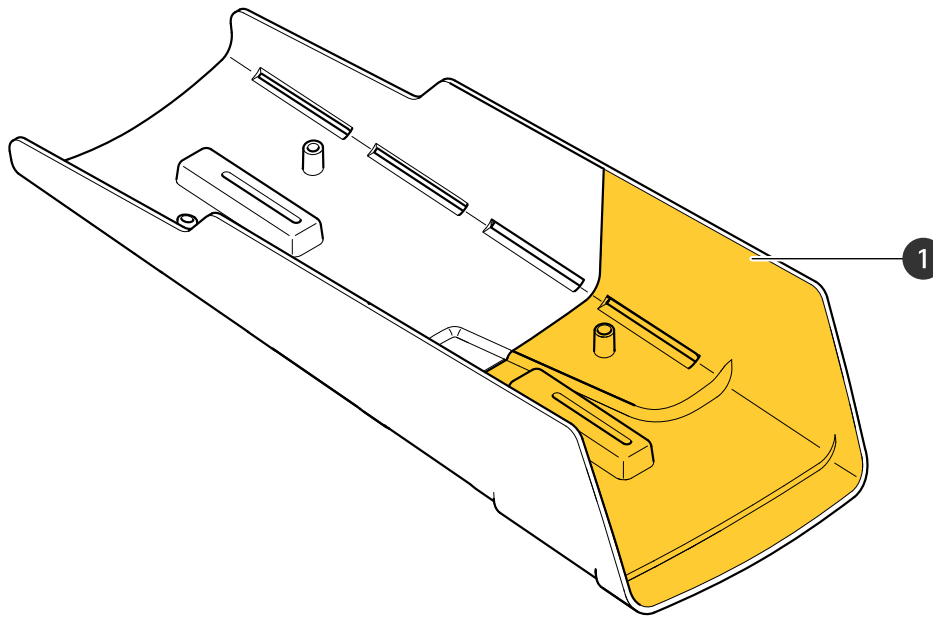
## Masking the weathershield

1 Black

Mask the black part of the weathershield.
